Central Park Master Plan

Louisville, Kentucky

Louisville Metro Parks

July 27, 2005

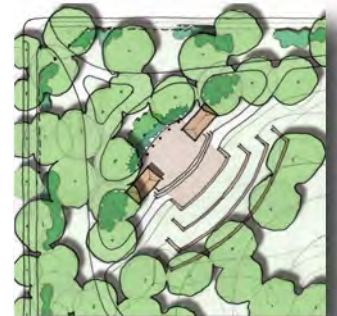
Alternate Location

An alternative location for the amphitheater (*shown at above*) was studied but was determined unacceptable due to its orientation and proximity to the intersection of Sixth Street and Park Avenue.

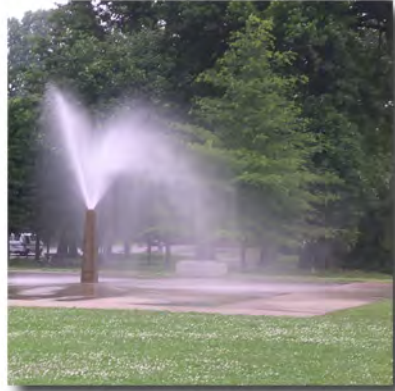
In time and when the existing play equipment and spray pool become antiquated or unsafe we have proposed relocating the new play area to the north of the proposed new pergola and gazebo.

The new play area separates the older children's play area from the younger children. The younger play area was further divided into two areas to provide greater parental control over play groups and play ability. The revised and smaller water play area is situated between the older play area and the younger play area offering easy access to both age groups. The spray pool is smaller because the overspray has been contained in a smaller area by not using fine droplets that can be blow down wind. It is our recommendation that several courser spray units be directed into the pool area to create more play separation. South of the new Gazebo is The Green which is in terms of space an open lawn. This lawn is defined by plantings and the new pergola and doubles as extra event space west of the Courtyard.

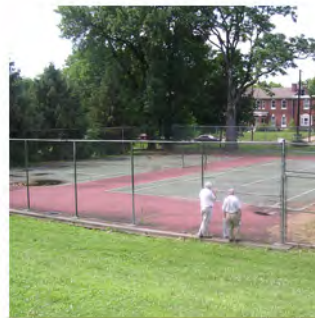
Tennis courts to be removed

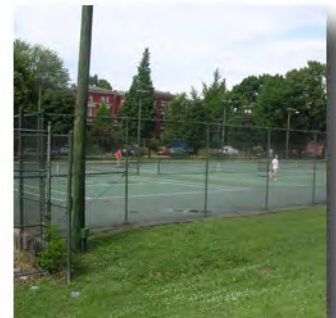
Tennis courts to be rebuilt

- Develop a sense of entry at the tennis courts from Park Avenue.
- Organize site furnishings to reduce clutter.
- Rebuild and maintain six courts as required to keep them playable.
- Provide temporary tournament seating on adjacent courts. Protect court surfaces as necessary.

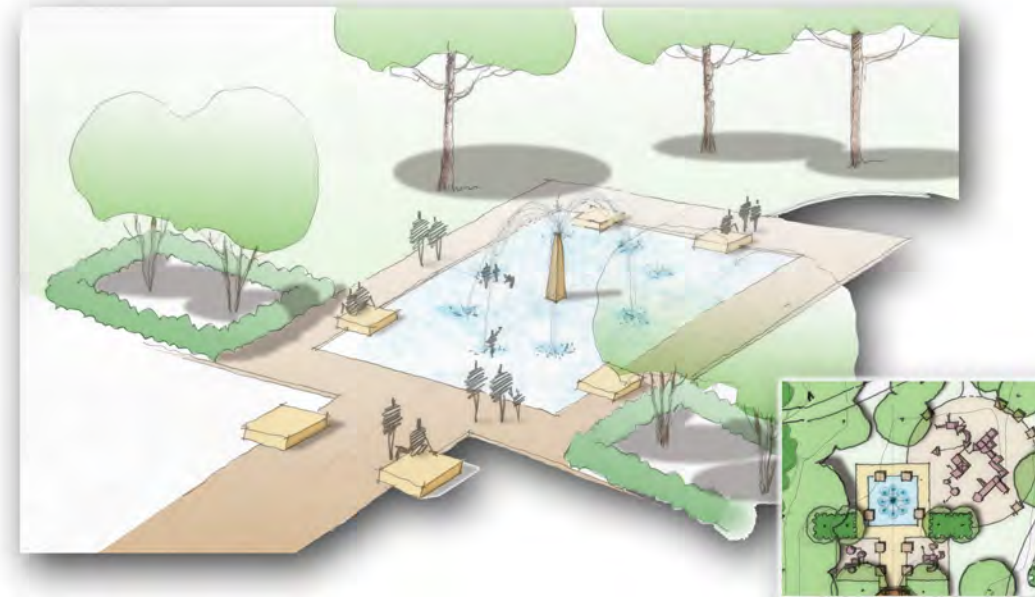
Water Play area with Platform Seating

- When replacement is required, shift Playground north to incorporate spray pool.
 - Design specific, adjacent playground sections to meet developmental needs of 2-6 year-olds and 6-12 year-olds.
